## 测试报告

No. SZXEC2101193601

以下测试之样品是由申请者所提供及确认: CSY22 铝合金

### RoHS指令2011/65/EU附录II的修正指令(EU) 2015/863

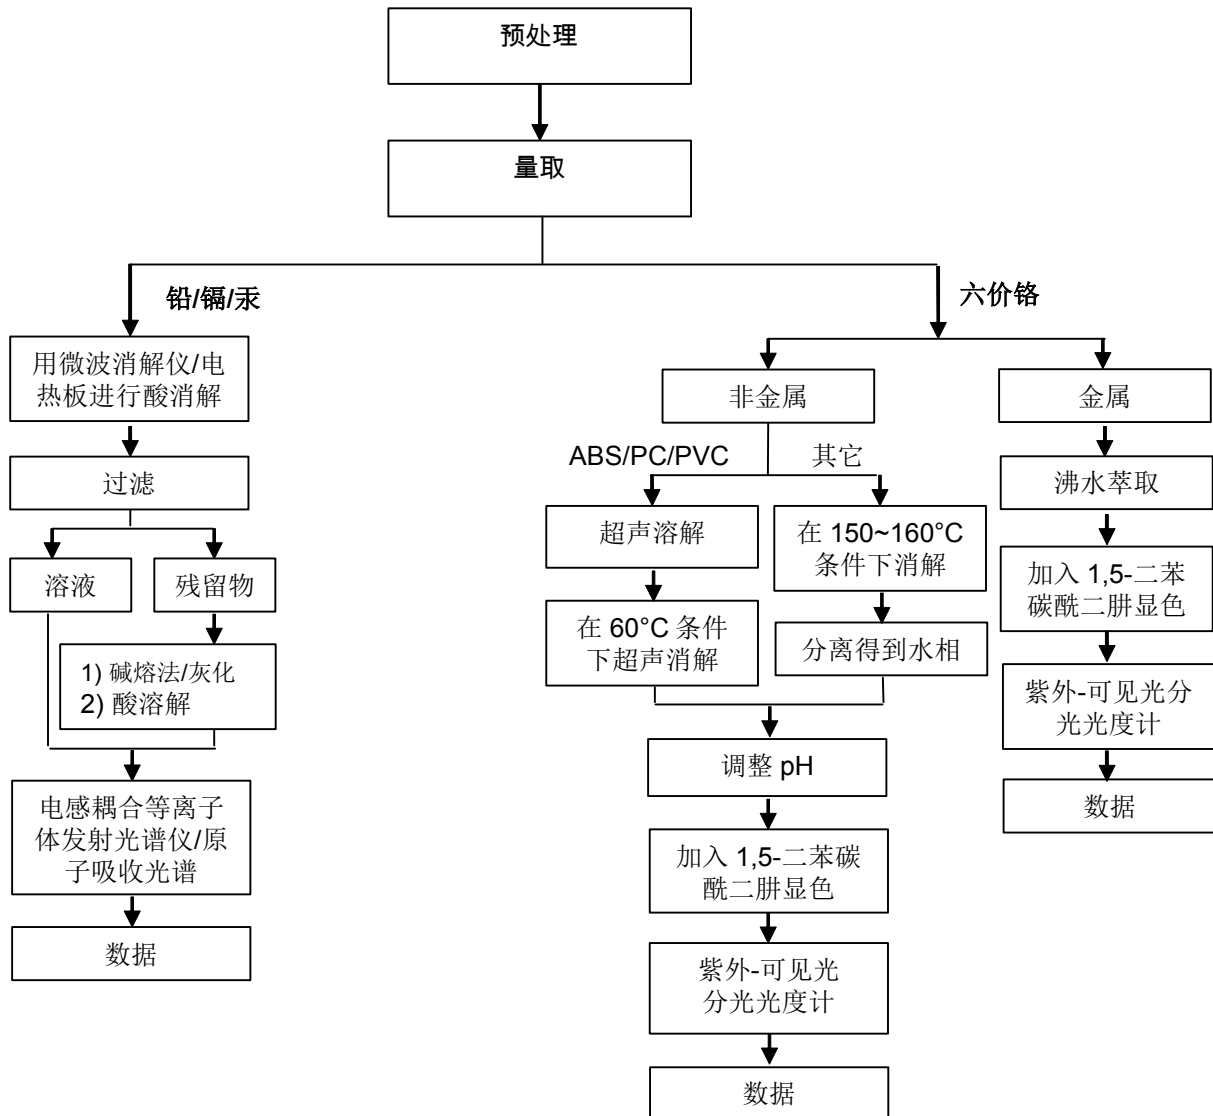
## Pb/Cd/Hg/Cr<sup>6+</sup> 测试流程图

1) 样品按照下述流程被完全消解（六价铬测试除外）。

测试方法: 参考IEC 62321-4:2013+AMD1:2017, IEC 62321-5:2013 和IEC 62321-7-1:2015, 采用ICP-OES和UV-Vis 进行分析.

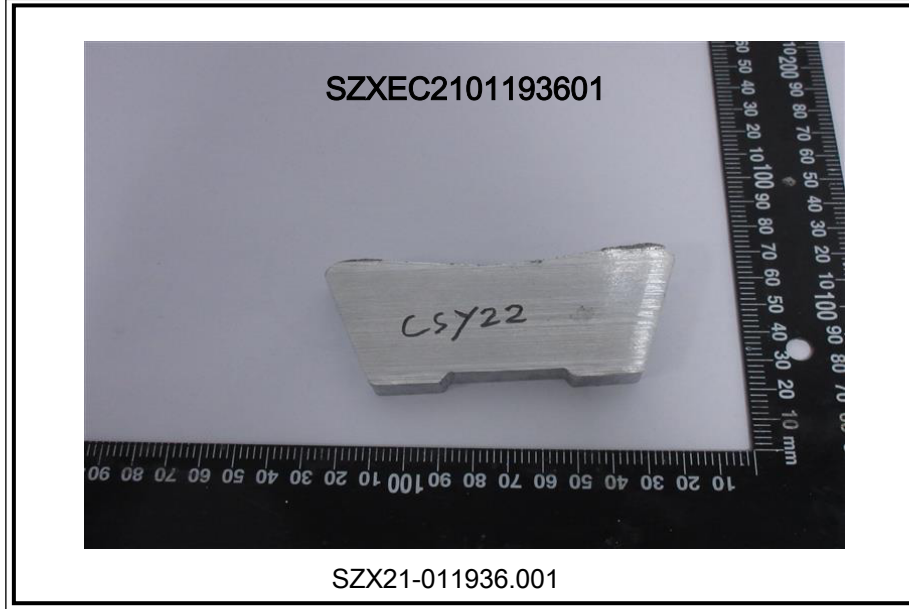
样品照片:

样品编号	SGS样品ID	描述
SN1	SZX21-011936.001	银灰色金属
